## Cornices, Gutter Systems & Flashing

## Preservation Guidelines: Cornices, Gutter Systems & Flashing

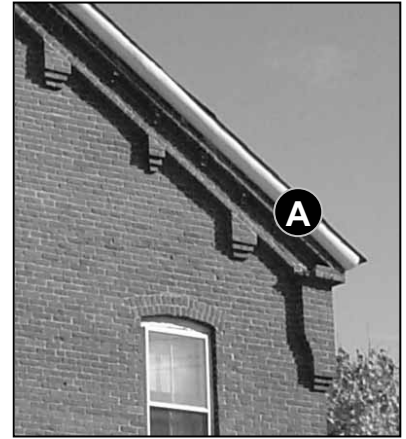
Fig. 5-48: 120 Benmont Ave. The eave detail here creates an intricate shadow and helps water drip away from the surface of the façade.

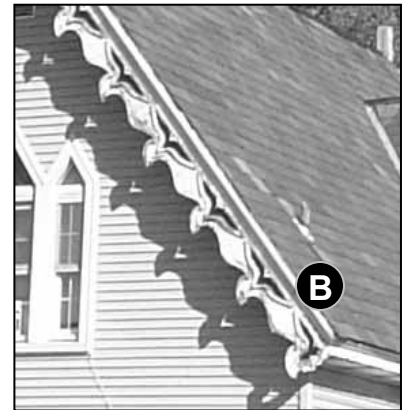
Fig. 5-49: 207 Depot St. The intricate eave on this house defines much of the architectural character, and should be protected.

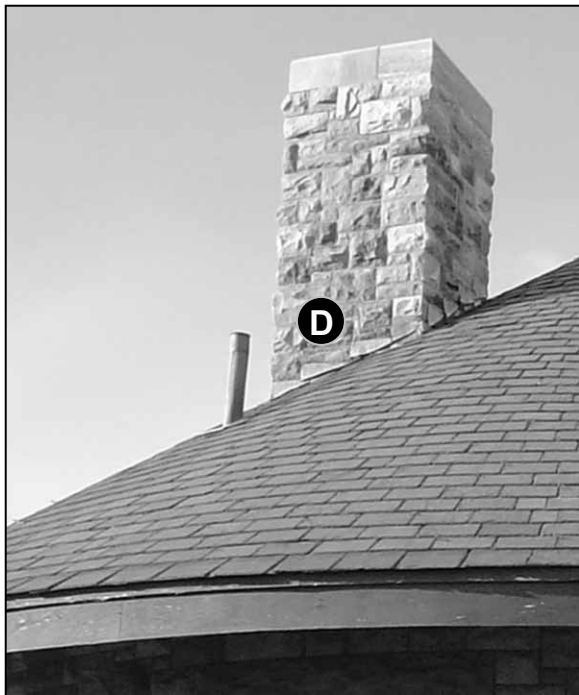
Fig. 5-50: 150 Depot St. The original soft-metal flashing along the bottom of this chimney remains in good condition, and has weathered to match the color of the stone.

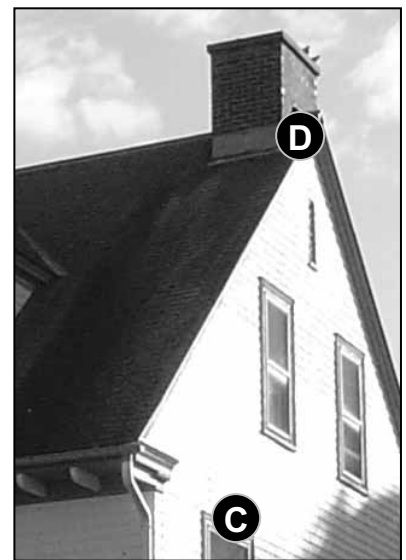
Fig. 5-51: 124 Elm St. Although the flashing and gutter system have been replaced, they match the general design and materials of the original home.

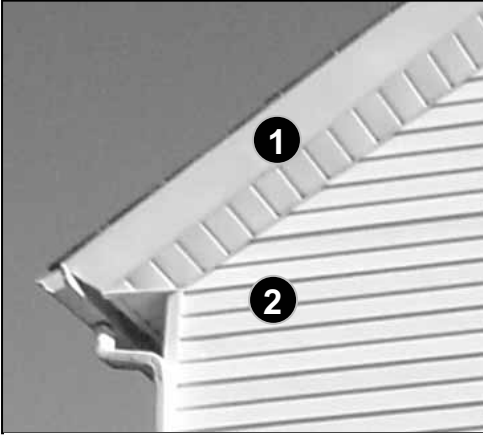
Fig. 5-52: 115 McKinley St. Vinyl siding conceals the original trim design of the façade.

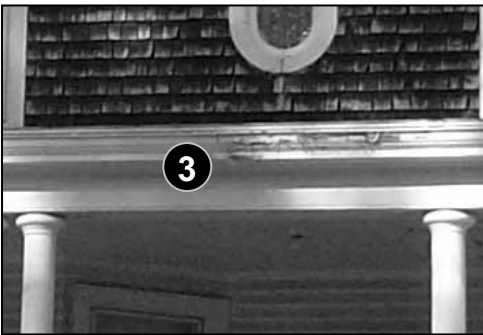
Fig. 5-53: 133 Elm St. The wood trim here is showing signs of moisture damage, and will get worse if left un-repaired.

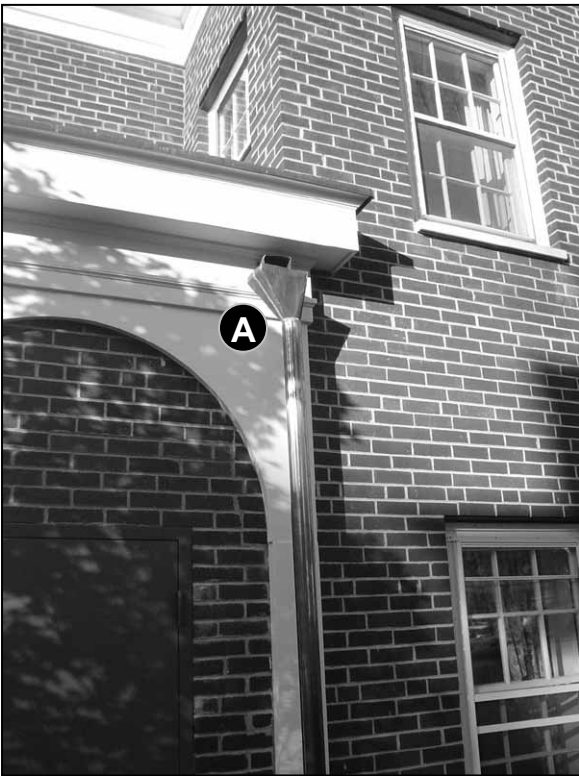
Fig. 5-54: 116 South St. A new copper downspout has been installed here to match the original materials.

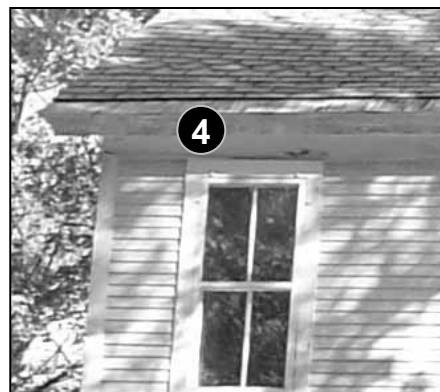
Fig. 5-55: 220 Silver St. The original copper eave flashing still remains along the edge of this roof.
